## Warm Mix Asphalt Site Report

Job No: PEI DOT Malpeque Road Rte 20  
Date (D/M/Y): July 23, 2010  
Other Job Reference: N/A  
Contractor/Agency: Curran & Briggs / PEI DOT  
Location: Malpeque Road (Rte 20) – 6 km N of Kensington

Job Description:  3G     DAT     ET  
Tack coat - Scratch and Overlay

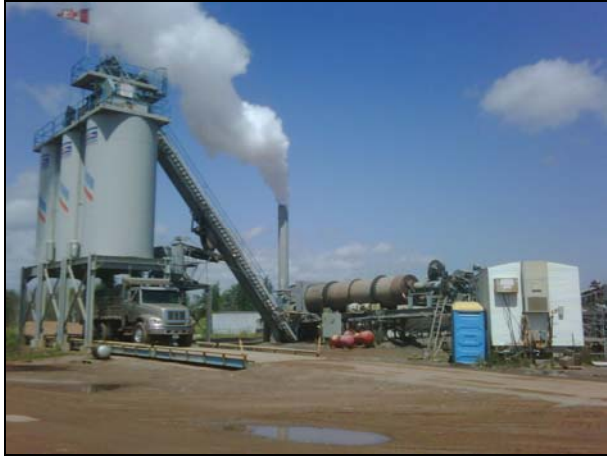
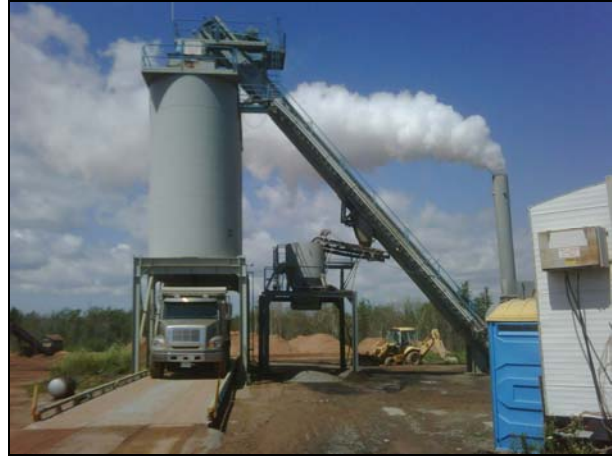
**Fig 1: Plant Production**

Plant – 160 tph, ran mix out of silos  
 AC Content – 6.1%  
 No issues with production, no mechanical issues  
 Truck boxes cleaner (comments from truckers)  
 Preliminary test results showed all physical properties being met  
 Crew liked mix, no fumes  
 Easy to work with

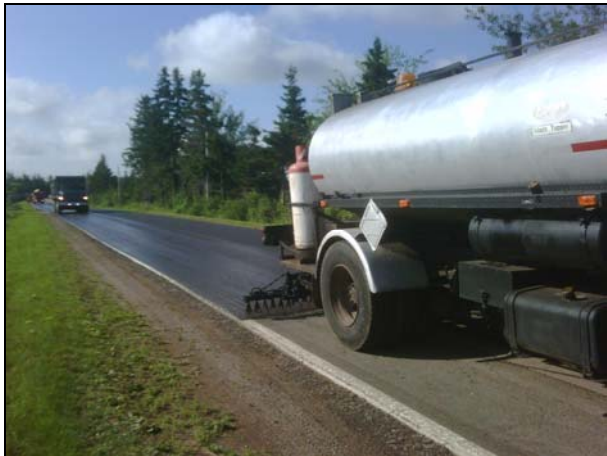
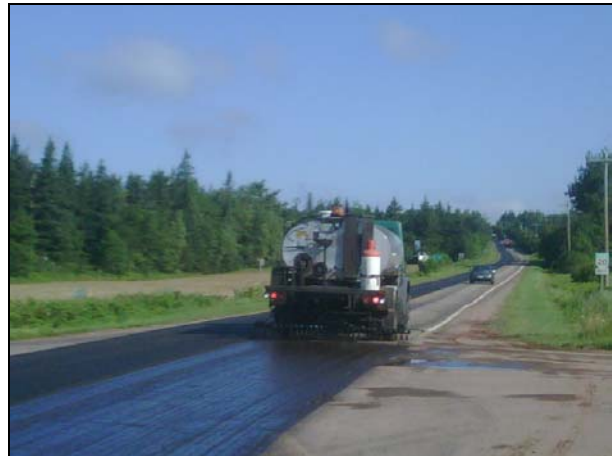
**Fig 2: Tack Application**

Description of Task	Yes	No	Comments
Tack Coat Type?	√		SSID
Tack Coat homogeneous?	√		See photos
Were all surfaces clean prior to tacking ?	√		
Spray nozzles all at the same angle?	√		
Was the surface free of signs of moisture?	√		
Were the rollers keeping up?	√		
Did the spreader stop frequently ?	√		After each round of trucks
Was a shuttle buggy used ?		√	
Were the WMA trucks tarped?	√	√	Some

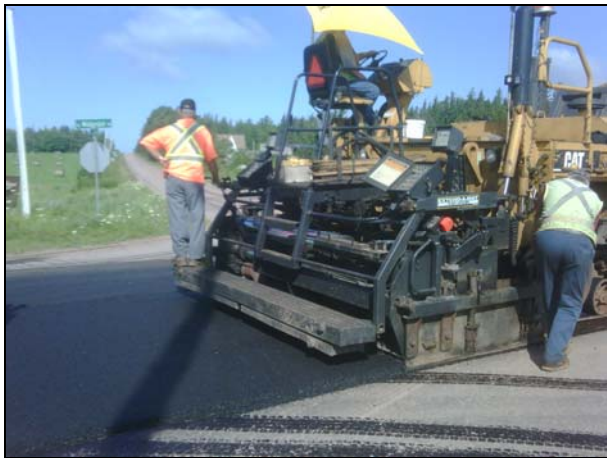
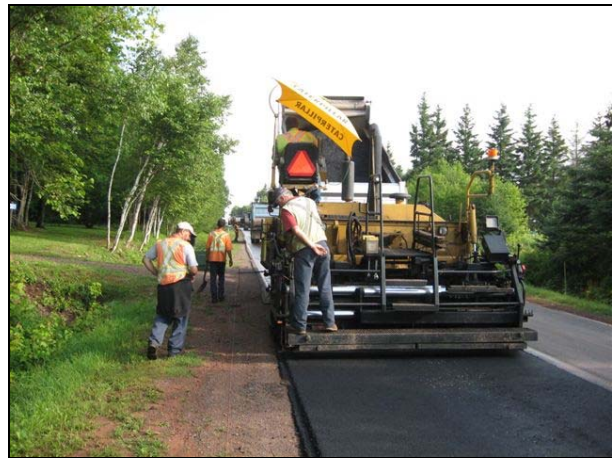
**Fig 3: Laydown**

- Mix Type: PEI Mix B
- A/C Type: PG 58-28
- A/C Source: McAsphalt – Eastern Passage
- Temp. of A/C in Storage Tanks: ≈ 150°C
- Anti-stripping Type and Amt: None
- McAsphalt Ticket No(s): \_\_\_\_\_
- WMA Discharge Temperature: 130±2°C
- WMA Laydown Temperature: 115 - 125°C (Hopper) 110 - 122°C (behind Spreader)
- Compaction Equipment Used: AP 1055B Spreader; CB 534 DXW Cat Vibratory Steel  
CP 271 Dynapac pneumatic
