Warm Mix Asphalt Site Report

Job No: NBDOT Rte 144 (10-0796)
Date (D/M/Y): Aug 25, 2010
Other Job Reference: N/A
Contractor/Agency: Ray's Paving Ltd/NBDOT
Location: Rte 144 in North West N.B. Doucet Rd to Ste-Anne Village limits
Job Description: 3GV DAT ET
Milling followed by WMA-D Surface Mix.

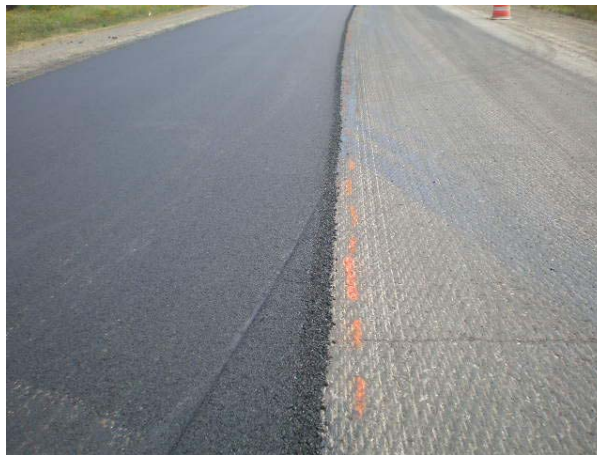
- This job is an ERS / End Result Spec (i.e. Item 261)
- Even though the TSR ratio was acceptable during the mix design stage (~82% > 75% min specified) the NBDOT requested that antistrip be added just to be safe. For that reason the NBDOT paid for its addition to the liquid. However, the agency did state that regular HMA mixes without antistrip, with this rock, would have much lower TSRs. This is good evidence confirming that our Evotherm additive can greatly improve the stripping resistance.
- Production today was @ ~130MT/hr
- FYI Lot #1 from last week had 95% density = 100% bonus!!
- WMA mat was very stable. See pic 1.

Pic 1: DD Vib turning off very stable unconfined edge

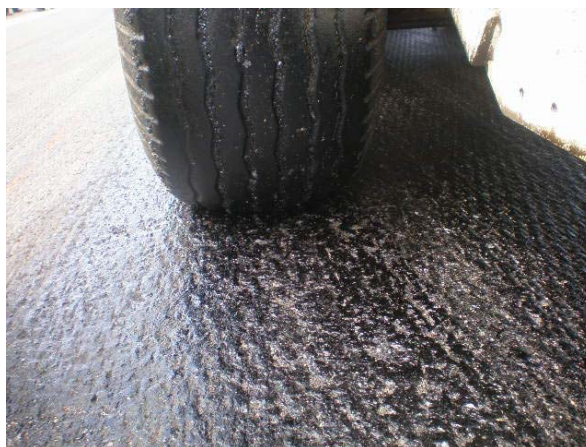
- Tack was very uniform in the NBL and did not pick-up. See pic 2.

Pic. 2: Tack uniform in NBL with no pick-up on shuttle buggy tire

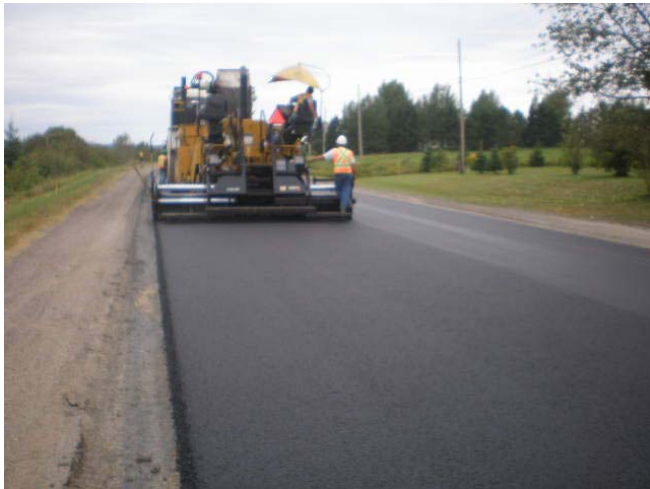
- Mat texture behind screed was uniform. See pic. 3:

Pic 3: Uniform texture behind screed

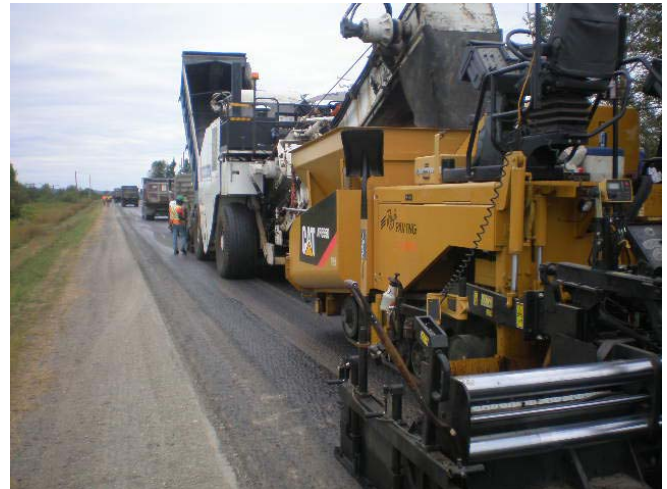
Pic 4: Shuttle buggy ensuring constant paver movement and smoother mat
